Water Tower Rehabilitation Update

CITY OF FOWLER

JANUARY 2024

Water Tower Structural Analysis & Materials Testing findings

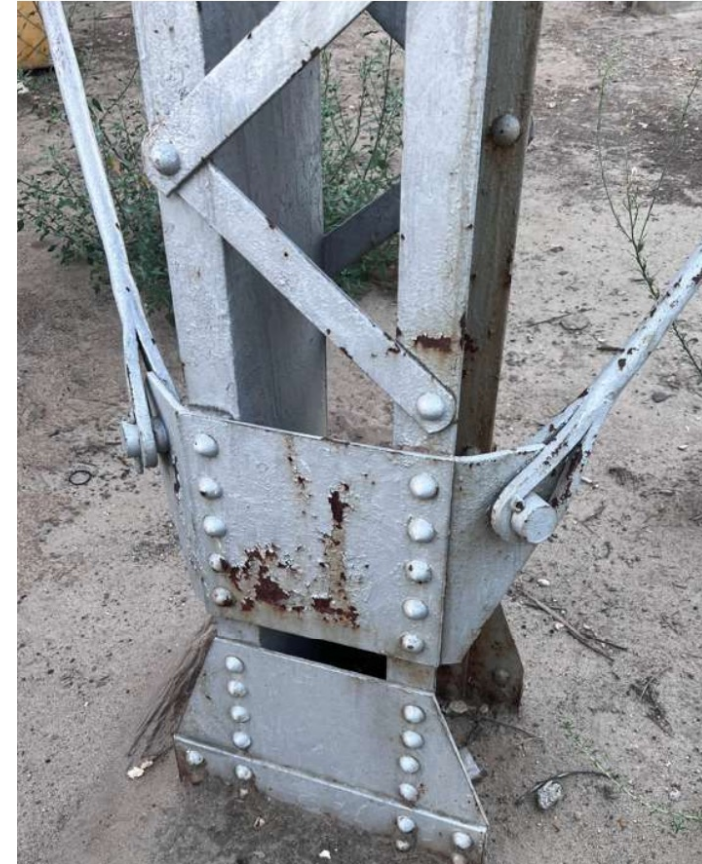
- Dewberry Engineers, the selected consultant, has identified the following deficiencies:
 - Potential for uplift of the water tower legs during a high wind event.
 - Existing coating of the tank and structure contain heavy metal contaminates
 - Corrosion at connections between the tank and the water tower legs.

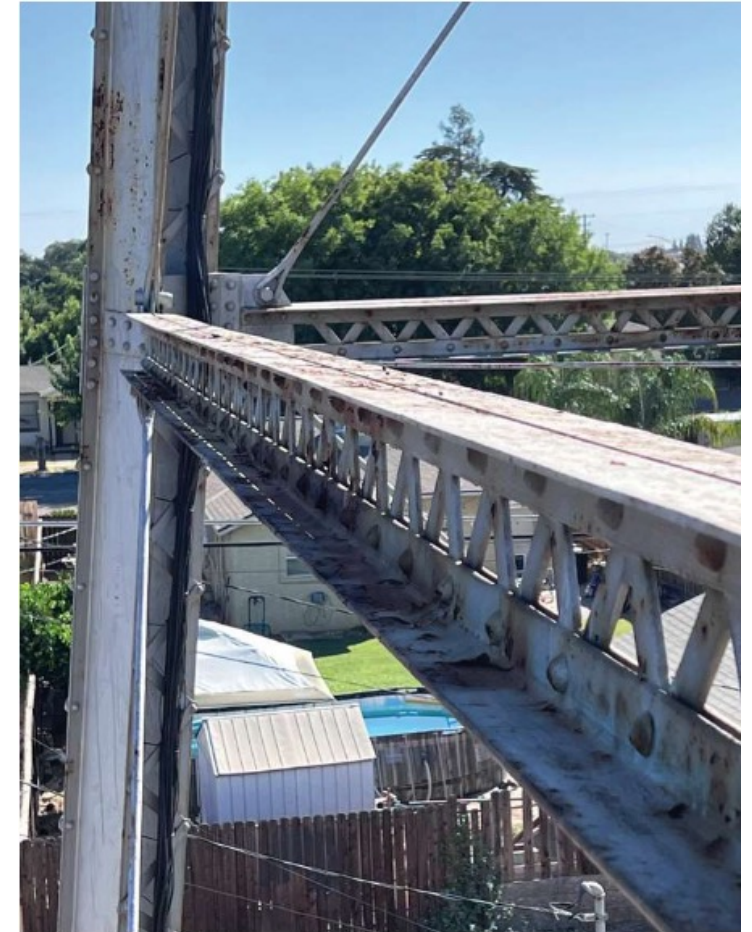
Option #1 Abate Existing Structure & Tank

- Approximate mitigation costs:
 - Concrete Block Installation to mitigate uplift
Estimate: \$20,000 - **underway**
 - Abatement and Coating Estimate:
\$600,000-\$1,000,000
 - Tank Aesthetics Improvement: \$50,000

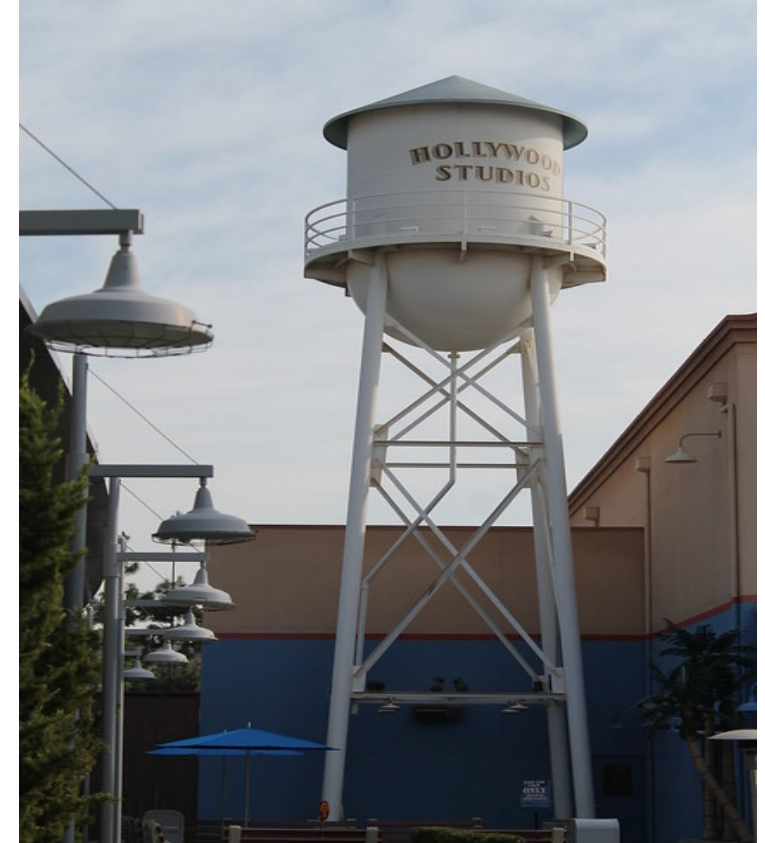
Option #2 Faux Tank

- Concrete block installation: \$20,000 - **underway**
- Old tank removal: \$100,000.
- Encapsulation coating for support legs, painting and installation: \$200,000.
- Faux tower design and construction: \$220,000.
